TECHNICAL REPORT REMR-CO-3

CASE HISTORIES OF CORPS BREAKWATER  
AND JETTY STRUCTURES

Report 3  
NORTH CENTRAL DIVISION

Robert R. Bottin, Jr.

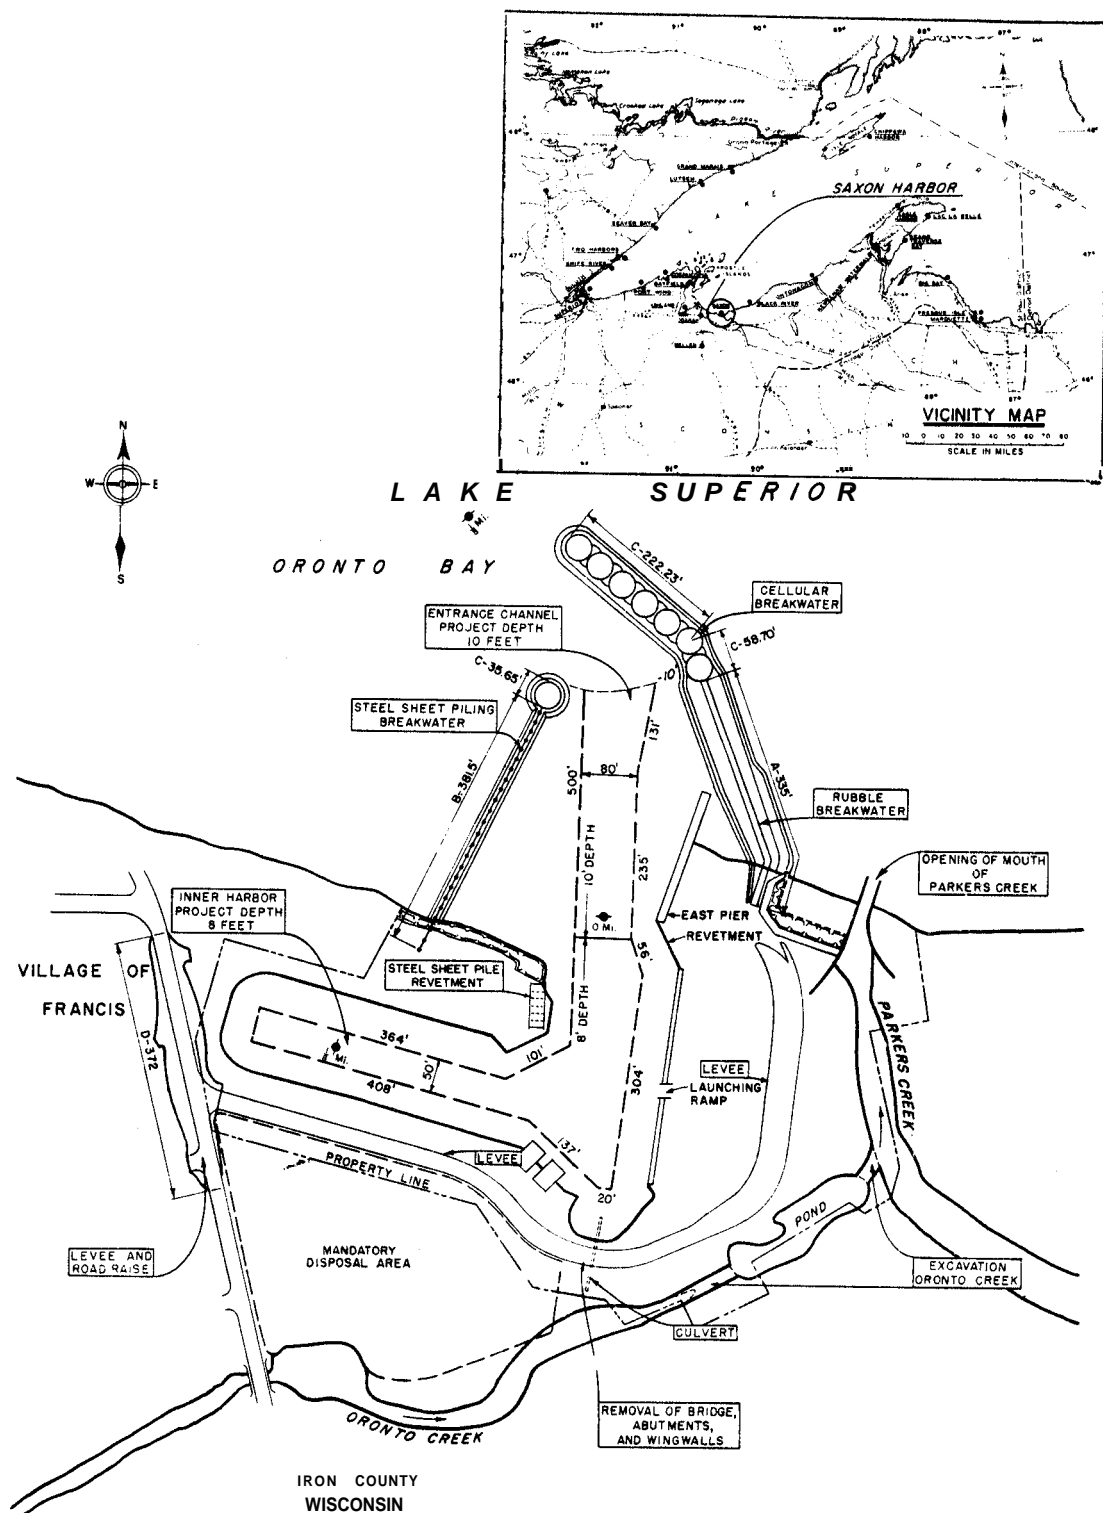
Figure 23. Saxon Harbor, Wisconsin

<u>Date(s)</u>	<u>Construction and Rehabilitation History</u>
1965	Construction of a 417-ft-long west breakwater and a 616-ft-long east breakwater was completed at the site (Figure 23). The shoreward <b>335</b> ft of the east breakwater was of rubble-mound construction. The crest el was <b>+8</b> ft lwd with an 8-ft width, and side slopes were <b>1V:1.5H</b> (Figure 24, Section A). Armor stone was approximately 6 ft thick. The shoreward 381.5 ft of the west breakwater was constructed of steel sheetpiling with rock toe protection (Figure 24, Section B). The crest el was <b>+8</b> ft lwd. The lakeward ends of both structures were cellular sheet pile (Figures 23 and 24, Section C). Cells with diameters of 35.65 ft were used. They were filled with excavation fill and capped with stone (voids filled with concrete). The crest el of the cells was <b>+8</b> ft lwd, and toe protection was included.

<b>1983</b>	An inspection made of the site indicated minor cracking of the cap of the innermost east breakwater cell. The cap of the outermost east breakwater cell was also noted cracking with a void in the center of the cap. In addition, the cap had settled as much as <b>8</b> in. in some areas.
1986	The structures have undergone only routine maintenance and presently are in good condition.

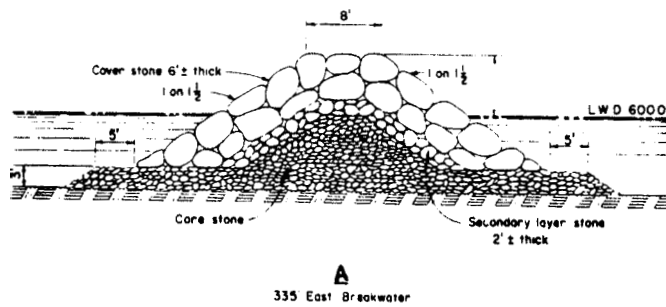
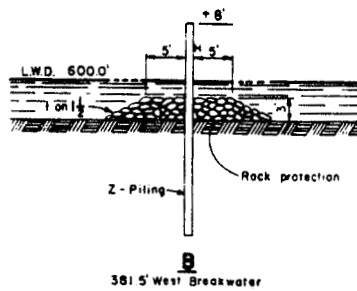
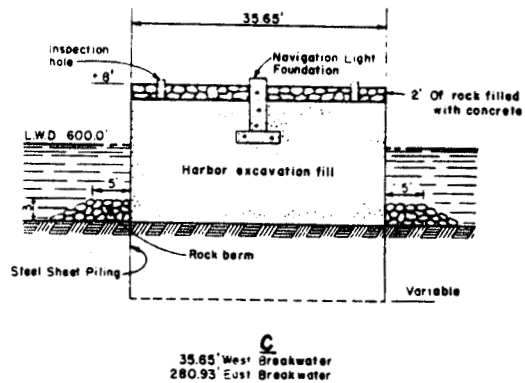
Figure 24. Typical breakwater cross sections, Saxon Harbor, Wisconsin

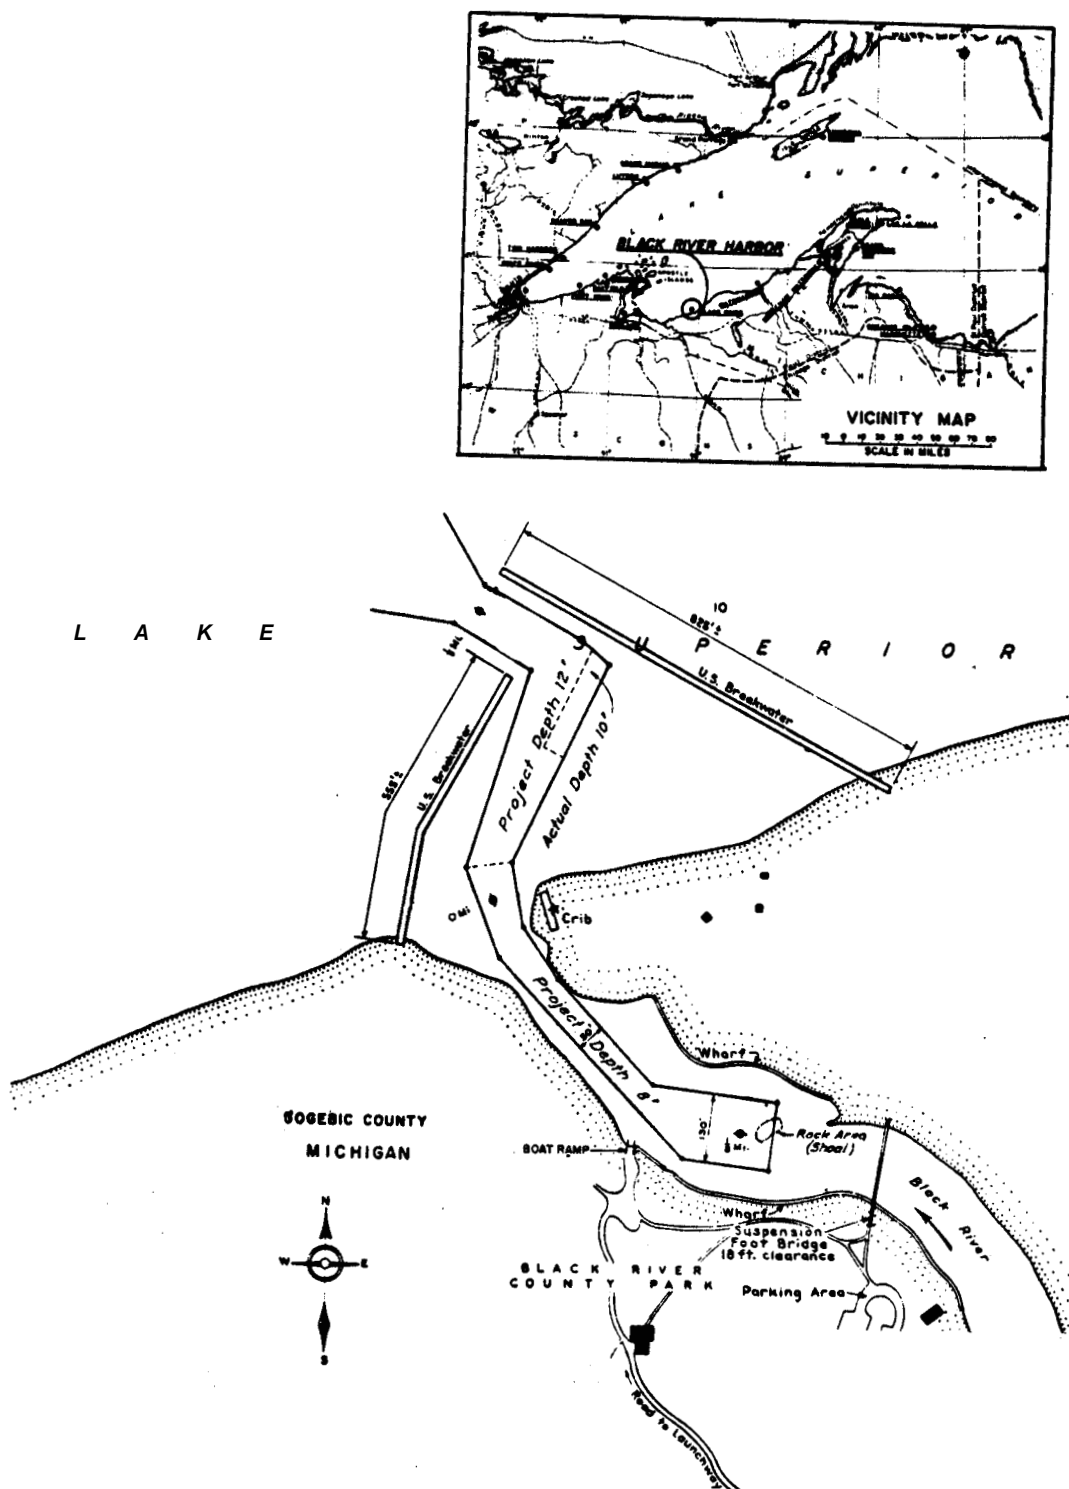
Figure 25. Black River Harbor, Michigan

Date(s)	Construction and Rehabilitation History
1957	The construction of an 825-ft-long east breakwater and a 555-ft-long west breakwater was completed at the site (Figure 25). The breakwaters were of rubble-mound construction (Figure 26) with crest elevations of +7 ft lwd and crest widths of 8 ft. Side slopes were 1V:1.5H, and 3-ton minimum armor stone was used.
1983	An inspection made of the structures revealed that both breakwaters were in good condition with the exception of several areas on each structure that needed additional core and cover stone.
1986	Since construction, the breakwaters have been repaired during routine maintenance operations. They presently are in good condition. An aerial view of Black River Harbor breakwaters is shown in Figure 27.

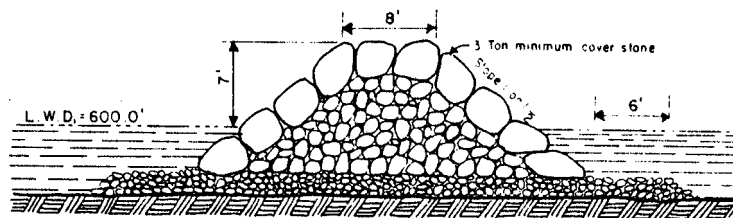
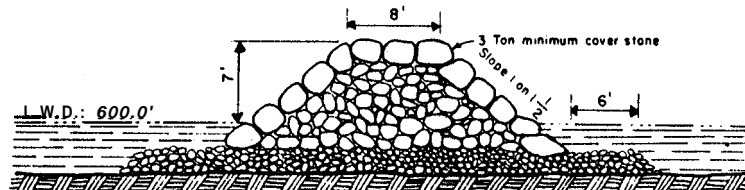
Lokeword End to - 5 Ft. Contour

- 5 Ft. Contour to + 2 Ft. Contour

Figure 26. Typical breakwater cross sections,  
Black River Harbor, Michigan

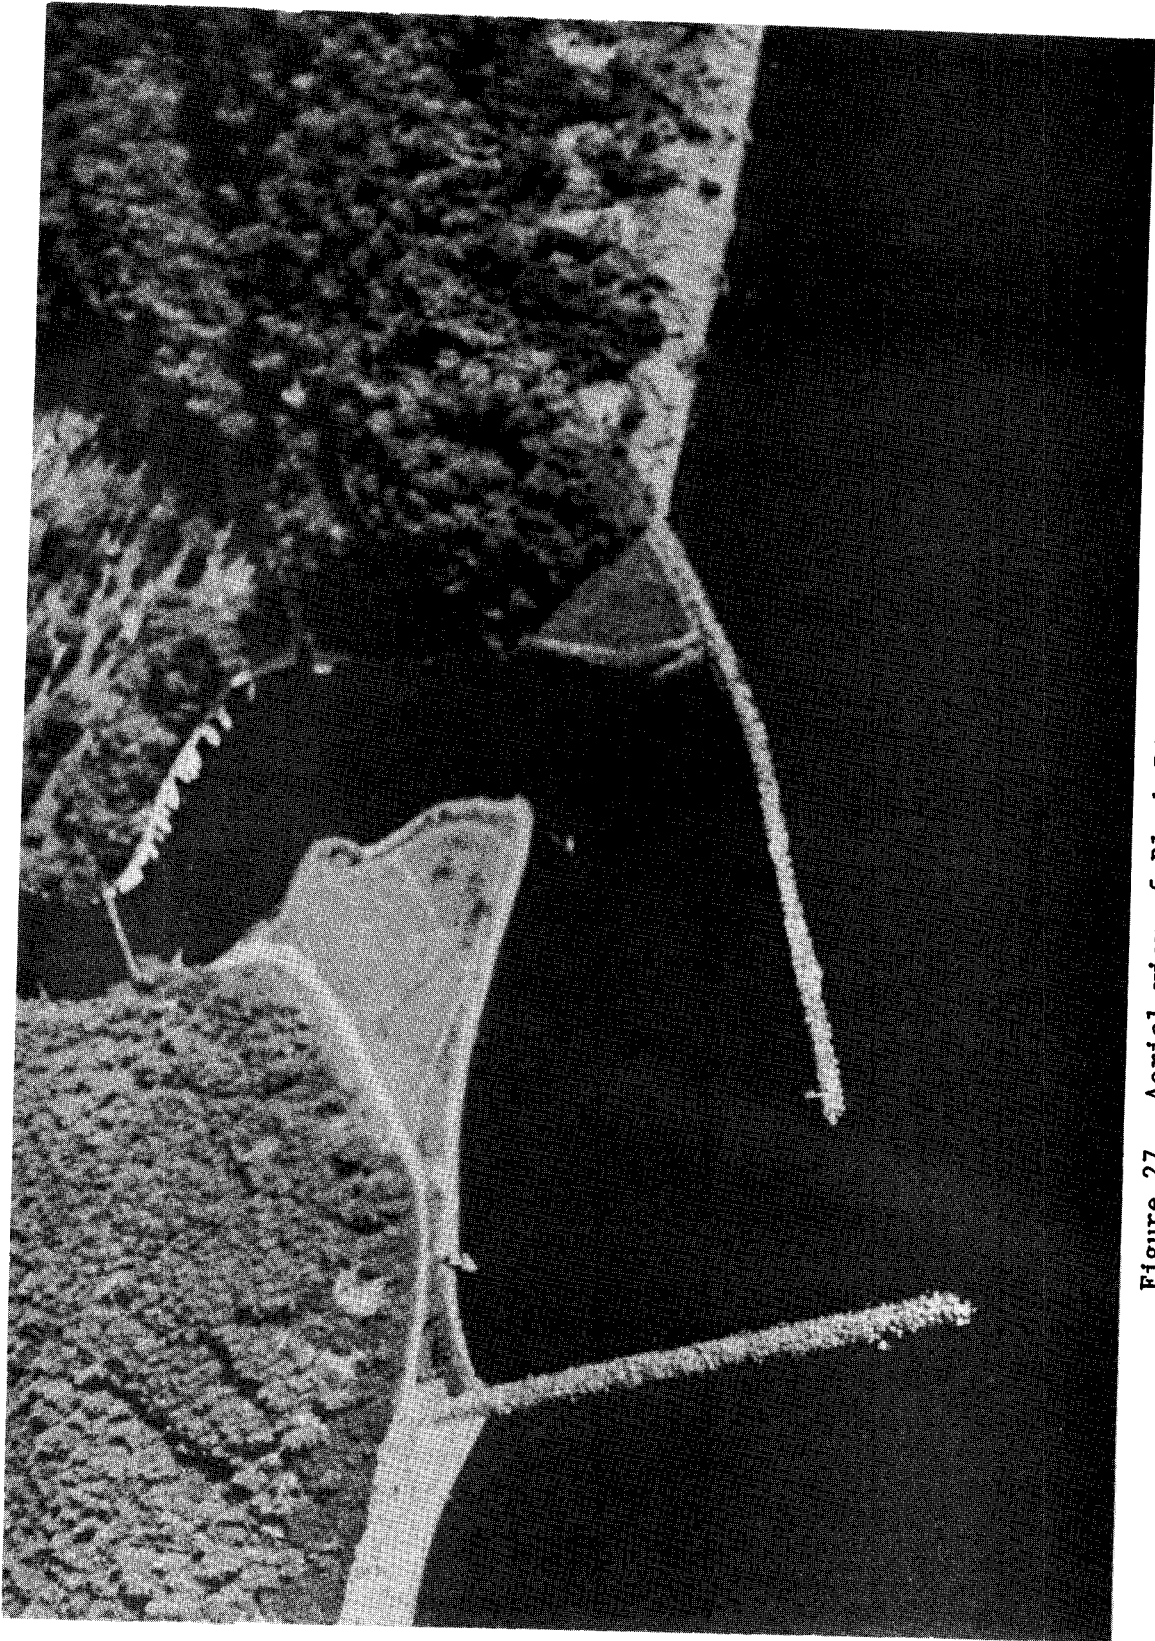
Figure 27. Aerial view of Black River Harbor, Michigan

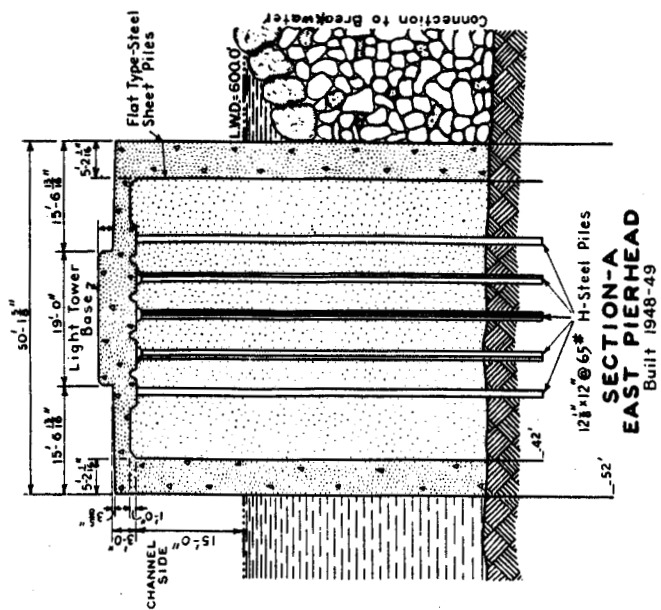
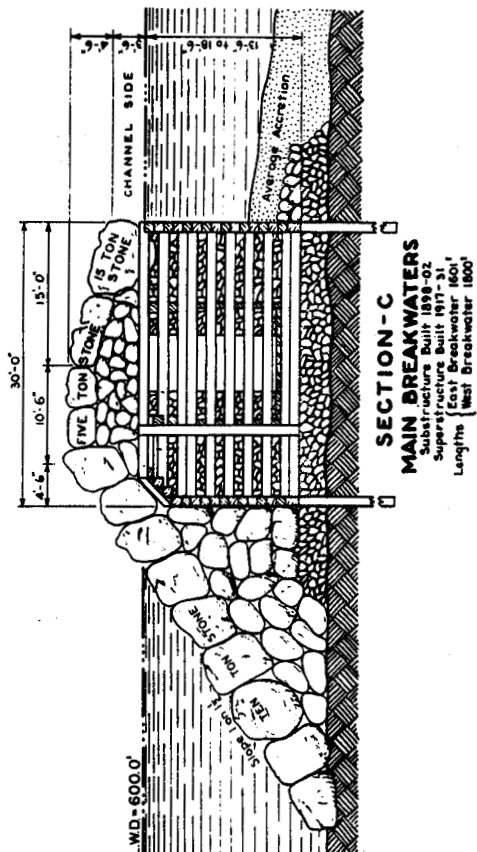
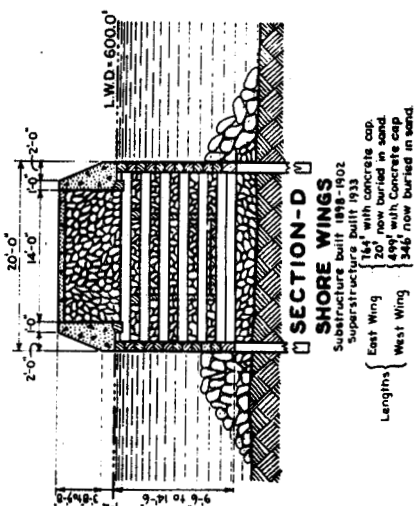
Figure 32. Upper entrance typical structure cross sections, Keweenaw Waterway, Michigan

### BREAKWATERS AT UPPER ENTRANCE

1948- 1949	Construction of the breakwater pierheads (Figures 31 and 32, Sections A and B) progressed during this period. The 50-ft-long east pierhead was built with steel sheet piles and sand, and the outer cover of the entire structure was built with concrete. The crest el of the structure was +18 ft lwd. The west pierhead was 50 ft long and constructed of concrete and steel sheet piles with a sand fill. The el of the structure was +10 ft lwd.
1986	The breakwaters at the Upper Entry have undergone routine maintenance and presently are in fair condition. Figure 33 is an aerial view of the upper entrance to Keweenaw Waterway.
<u>South (Lower) Entry</u>	
1860	Construction on the inner 950 ft of the breakwater was completed by private interests (Figure 34, Section I-L). This structure was a stone-filled timber crib breakwater. The width of the shoreward 325 ft of breakwater was 13 ft, and the remaining structure was 30 ft wide to a point 912 ft from its origin. At this point, the structure width changed to 24 ft.

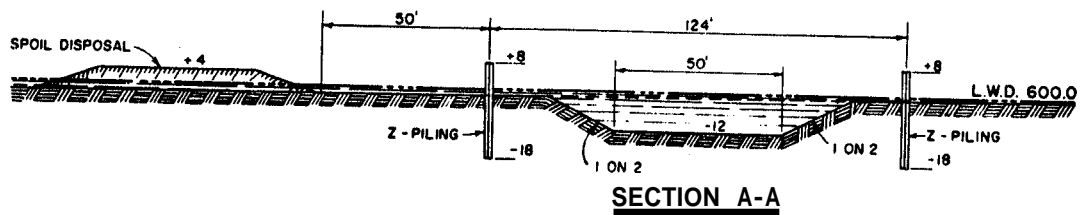
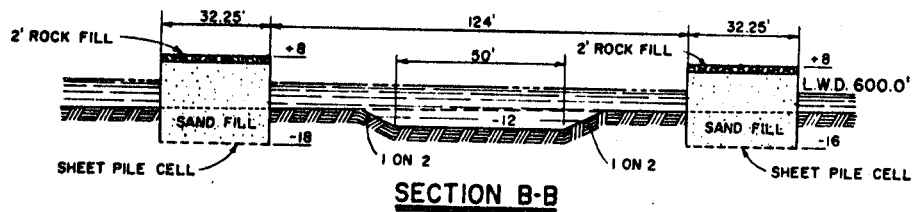
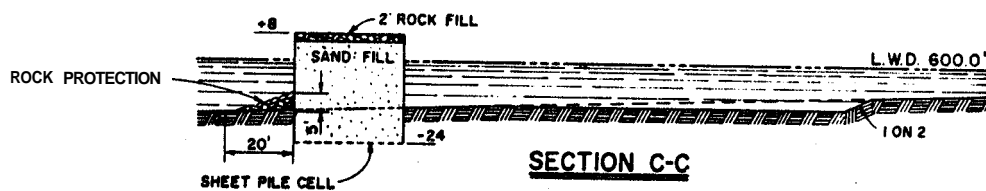
Figure 37. Typical structure cross sections,  
 Lac La Belle Harbor, Michigan

NORTH Z-PILING BREAKWATER = 458.5'  
 SOUTH Z-PILING BREAKWATER = 470.5'  
 SOUTH CELL BREAKWATER = 218.7'

BUILT 1959

Date(s)	Construction and Rehabilitation History
1959	Construction of two breakwaters was completed at the site (Figure 36). Three consisted of a 490-ft-long north breakwater and a 689-ft-long south breakwater. The north breakwater consisted of <b>a</b> 458-ft steel Z-piling section and a 32-ft cellular steel sheet-pile head. The south breakwater had a 470.5-ft steel Z-piling section with cellular steel sheet piles on the lakeward end cumulating over 218 ft in length (Figure 36). The Z-piling and the cellular structures were both built to an el of +8 ft lwd. The cellular sheet piles were 32 ft in diameter and were sand filled with a 2-ft rock cap (Figure 37). Rock toe protection was provided on the lakeside of the outer cells on the south breakwater.
1983	<b>An</b> inspection of the structures revealed a tipped section toward the channel on the south breakwater about 50 ft shoreward of the cells. Subsequently, the tipped section was straightened, and stone was added on the channel side to prevent scour.

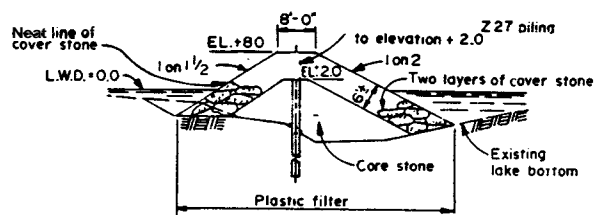
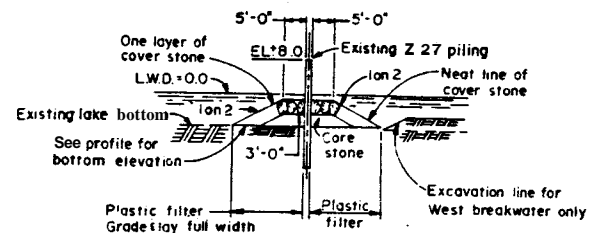
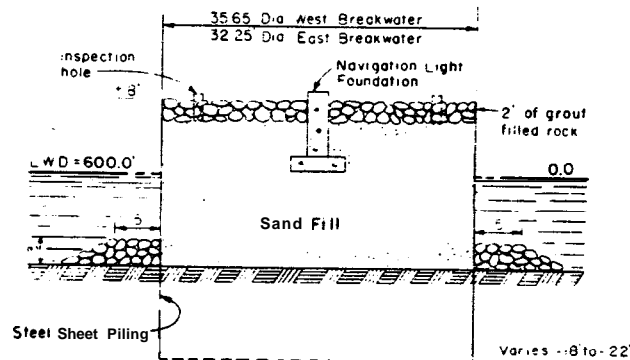
Figure 43. Typical breakwater cross sections, Big Bay Harbor, Michigan

**SECTION A**  
269' East Breakwater

**SECTION B**  
547' West Breakwater  
170' East Breakwater

**C**  
240 West Breakwater  
32 East Breakwater

Date(s)	Construction and Rehabilitation History
1960	Construction of a 471-ft-long east breakwater and a 787-ft-long west breakwater was completed at the site (Figure 42). The shoreward 269-ft-long portion of the east breakwater was rubble-mound (Figures 42 and 43, Section A). It had an 8-ft crest width and a +8-ft lwd crest el. Slopes on the lakeside were 1V:2H, and on the harbor side they were 1V:1.5H. The structure was built around steel sheet-piling which had an el of +2 ft lwd. From this point lakeward a steel sheet-pile structure extended an additional 170 ft (Figures 42 and 43, Section B). The shoreward 547 ft of the west breakwater utilized the same structure. The sheetpiling had a crest el of +8 ft lwd with stone toe protection on each side. The head of the east breakwater consisted of a cellular sheet pile (32 ft in diameter), and the lakeward 240 ft of the west breakwater was constructed of 36-ft-diameter cellular sheetpile (Figures 42 and 43, Section C). These cells were filled with sand and capped with 2 ft of grout-filled rock. Rubble toe protection was included also.

1969	The east breakwater was rehabilitated.
1979	An inspection of the harbor structures indicated that additional riprap was needed on both sides of the west breakwater (Figure 43, Section B). The stone was eventually placed.
1986	The breakwaters presently are in good condition. <b>An</b> aerial view of Big Bay Harbor breakwaters is shown in Figure 44.

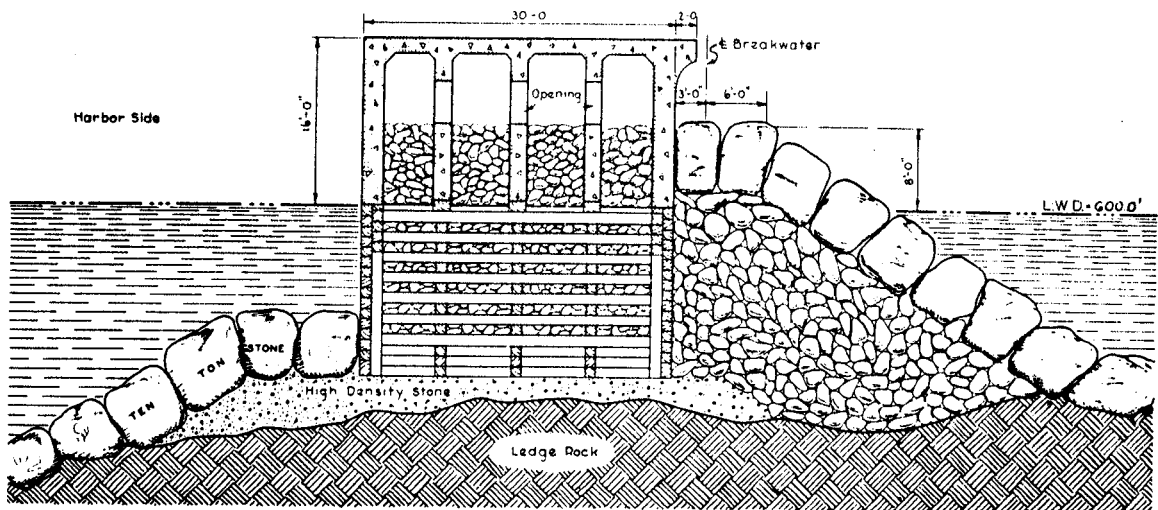
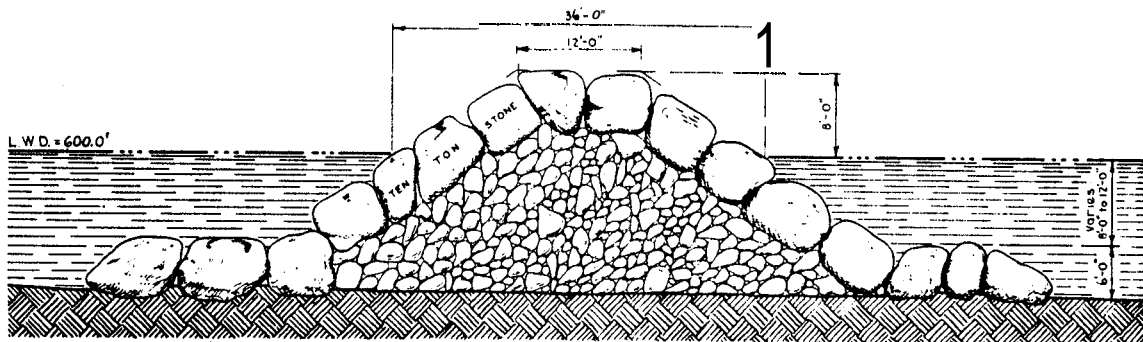
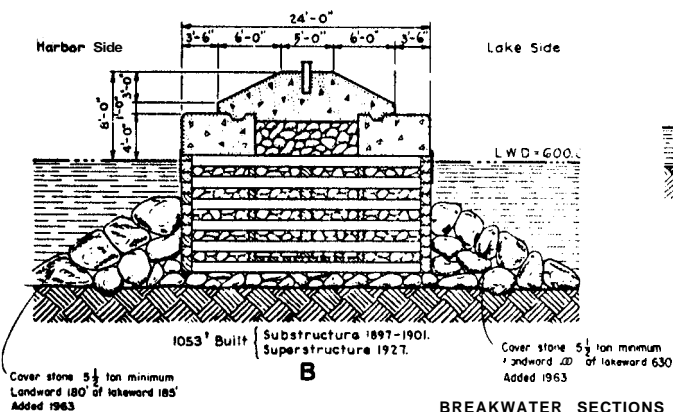
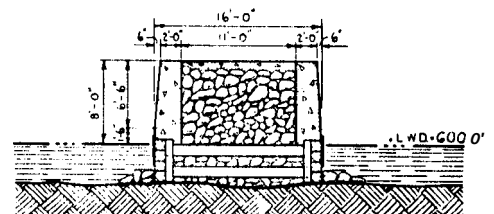
Figure 46. Typical breakwater cross sections,  
Presque Isle Harbor, Michigan

Lighthouse Foundation  
Built 1938.

Outer 1600 Built 1938-39.

1163' Built { Substructure 1903  
Superstructure 1927

# BREAKWATER SECTIONS

Date(s)	Construction and Rehabilitation History
1897-1901	Construction of a 1,053-ft-long breakwater was performed during this period (Figures 45 and 46, Section B). The structure was a 24-ft-wide stone-filled timber crib breakwater with riprap toe protection.
1903	A 163-ft-long stone-filled timber crib breakwater (16 ft wide) was completed connecting the original structure to shore (Figures 45 and 46, Section A).
1927	A stone and concrete capped superstructure was built on the existing structures (Figures 45 and 46, Sections A and B). The crest el of the structure was +8 ft lwd.
1938	Construction of the breakwater head was completed. The structure was a stone-filled timber crib breakwater that was 30 ft in width (Figures 45 and 46, Section D). The stone portion of the substructure and stone placed on the lakeward side of the breakwater were installed at an el of +8 ft lwd. Armor stone on the lakeside and toe protection on the harbor side of the structure were in the 10-ton range. The concrete superstructure was built to an el of +16 ft lwd for a lighthouse.

1938-1939	A 1,600-ft-long rubble-mound breakwater was constructed connecting the breakwater head to the existing structure (Figures 45 and 46, Section C). The crest was 12 ft wide with an el of +8 ft lwd. Ten-ton armor stone was used.
1963	Riprap cover stone (5.5 ton) was installed for a distance of 180 ft on the harbor side and 400 ft on the lakeward side of the original timber crib structure (Figure 46, Section B). The inner 1,216 ft of breakwater was rehabilitated for a cost of \$76,500.
1975	An inspection of the site indicated that the outermost portion of the rubble-mound breakwater needed some minor stone rearranging. This work was completed later in the year.
1986	The breakwater presently is in good condition. An aerial view of Presque Isle Harbor breakwater is <b>shown</b> in Figure 47.
